KOOTENTAI DEVELOPMENT IMPOUNDMENT DAM
TOE DRAIN INSPECTION II REPORT

July 27, 2010

BHI File No.: R.56.6

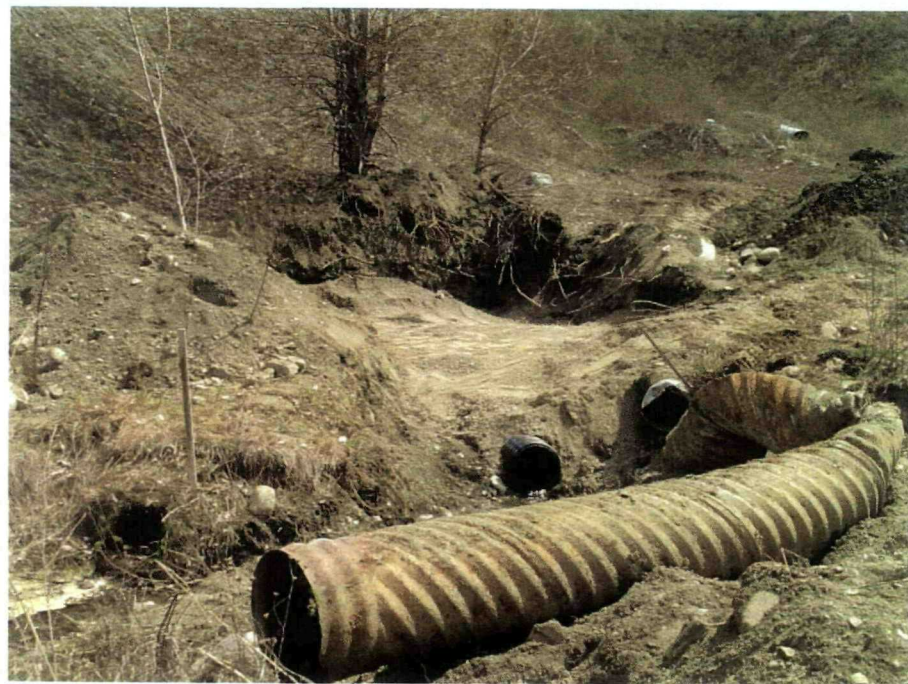
47. Fill near drain 2 & drain 1

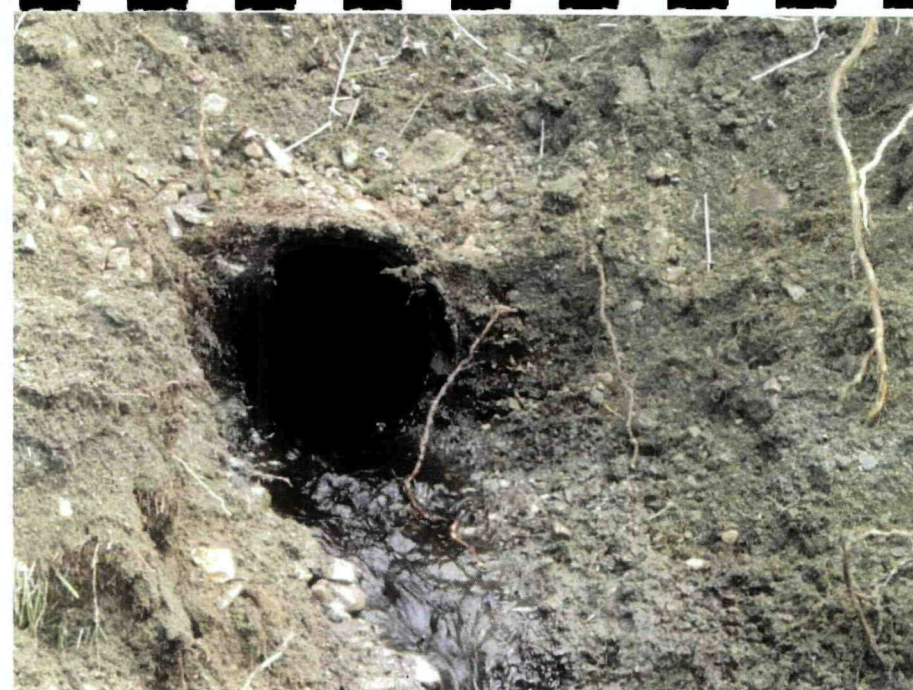
49. Outlet of drain 3

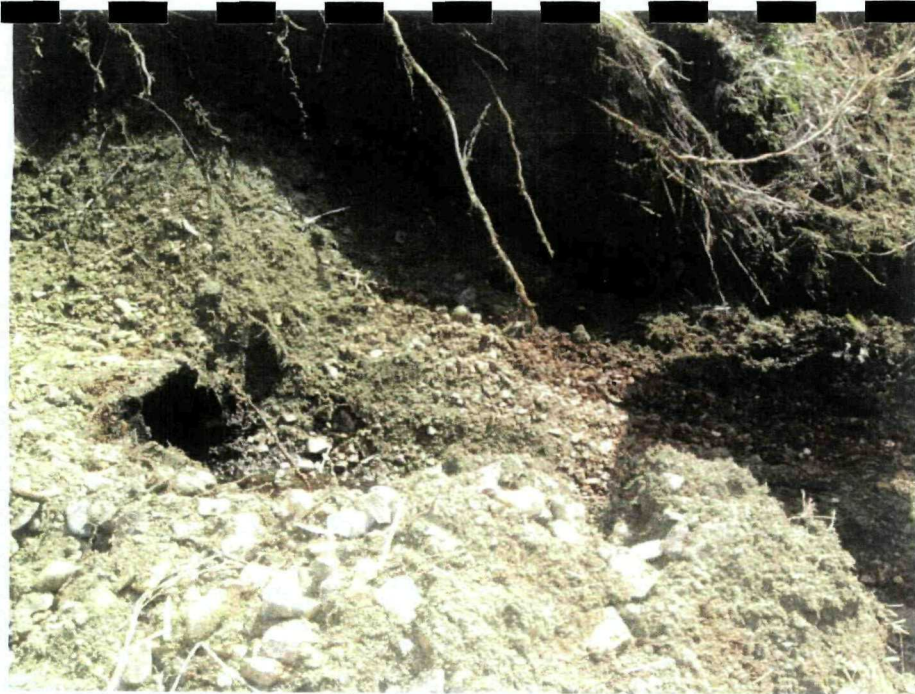
At the last section of pipe, drain 3 terminates in the same type of broken concrete, gravel, rock and water matrix that appears in all the other drains.

52. Drain 3 being excavated

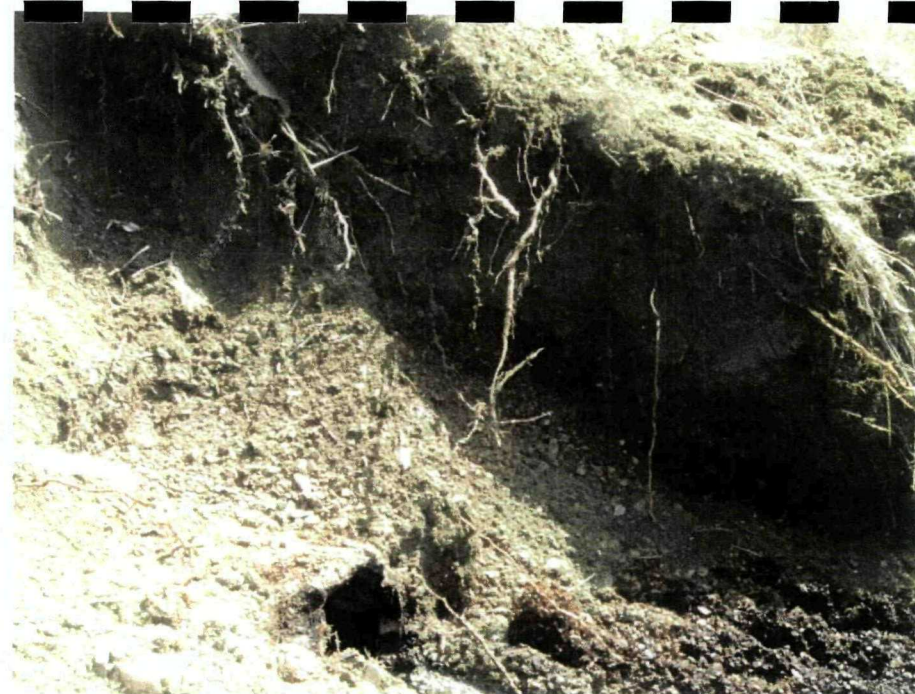
54. Drain 3 at outlet

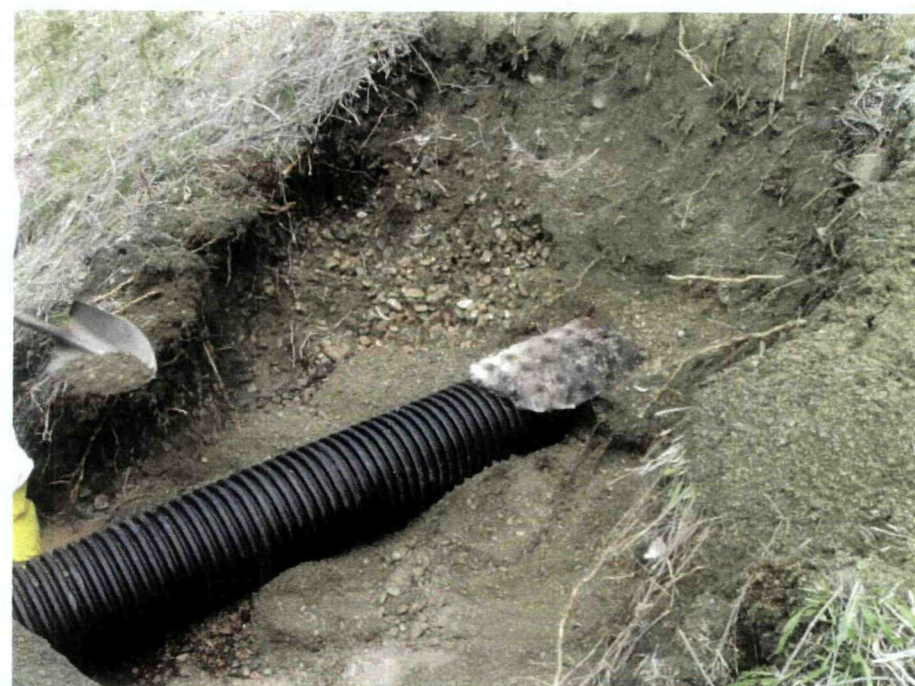
56. New outlet on drain 3 with broken concrete

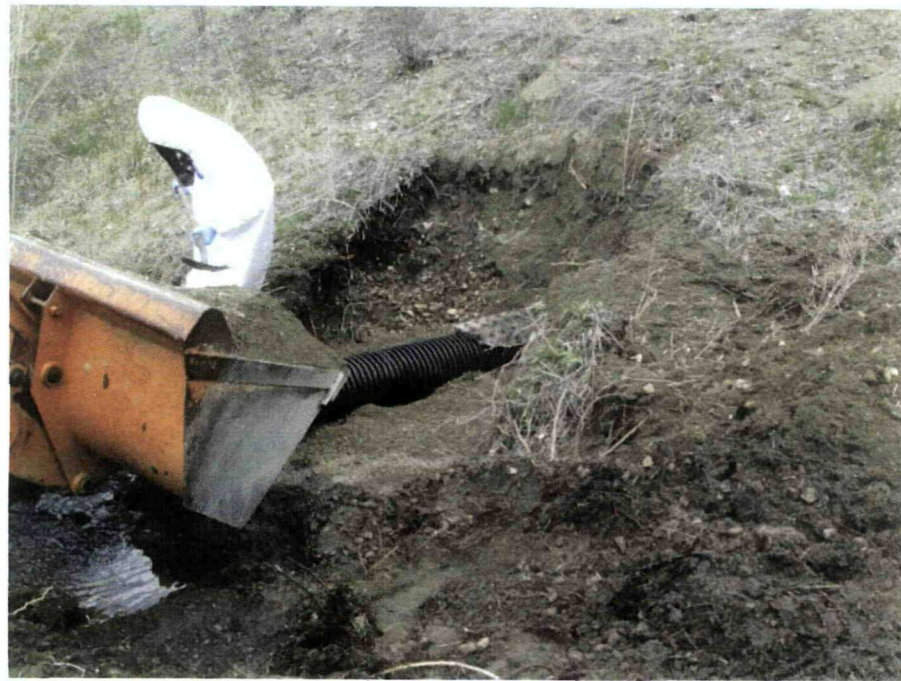
59. Backfilling drain 3

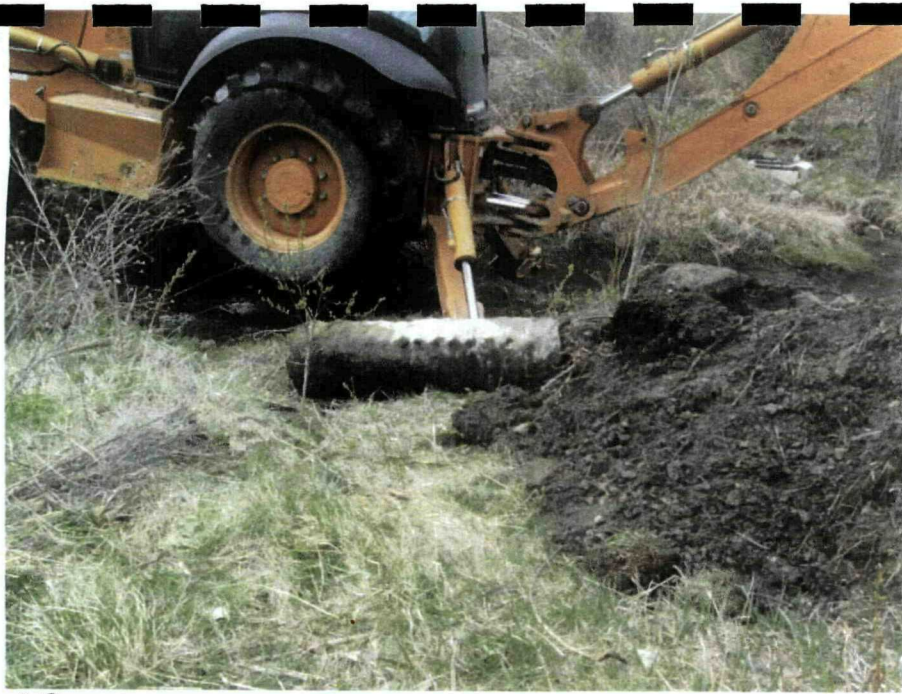
61. Note 1 1/2" round rock near drain 3

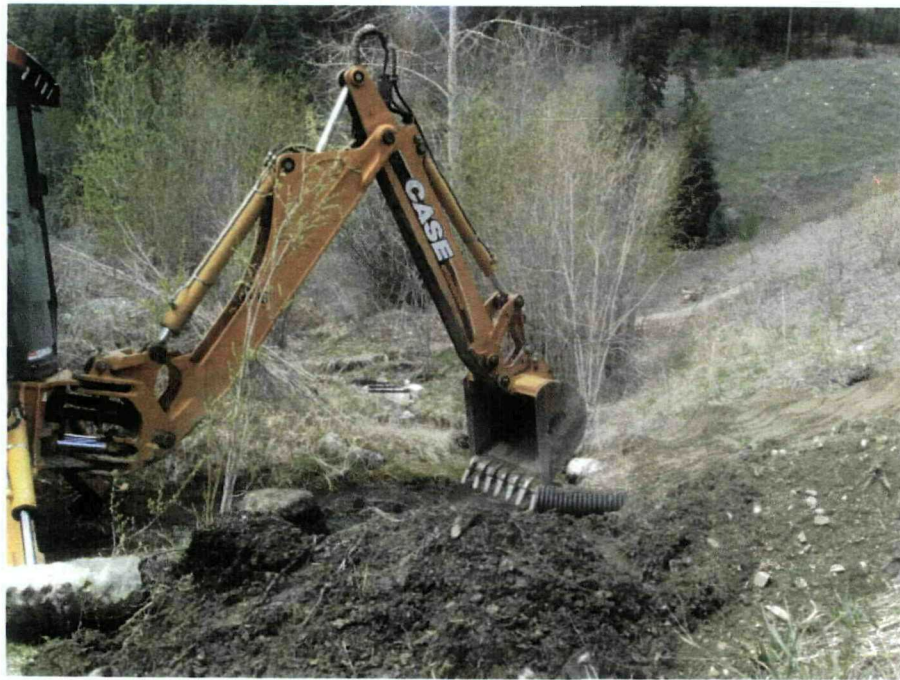
63. Backfill, drain 3

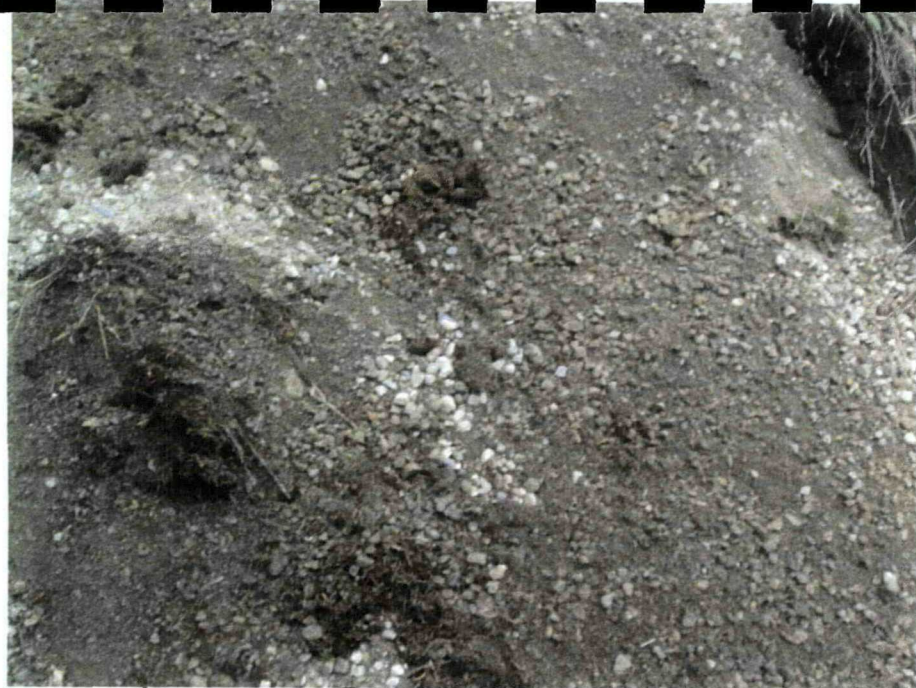
65. Inside new outlet, drain 3

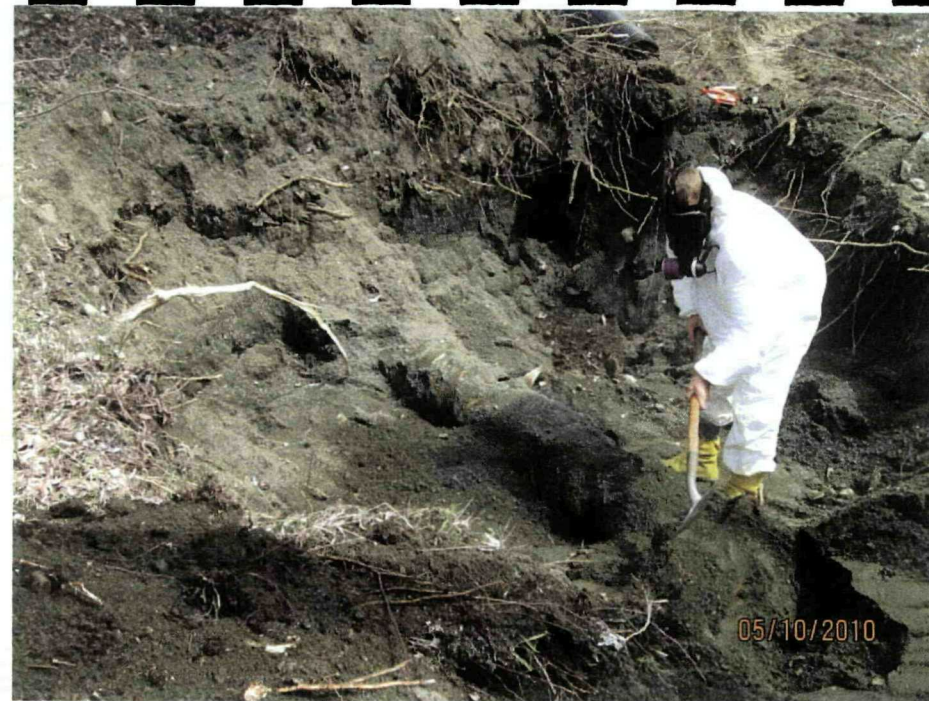
66. $\frac{3}{4}$ " minus fill material

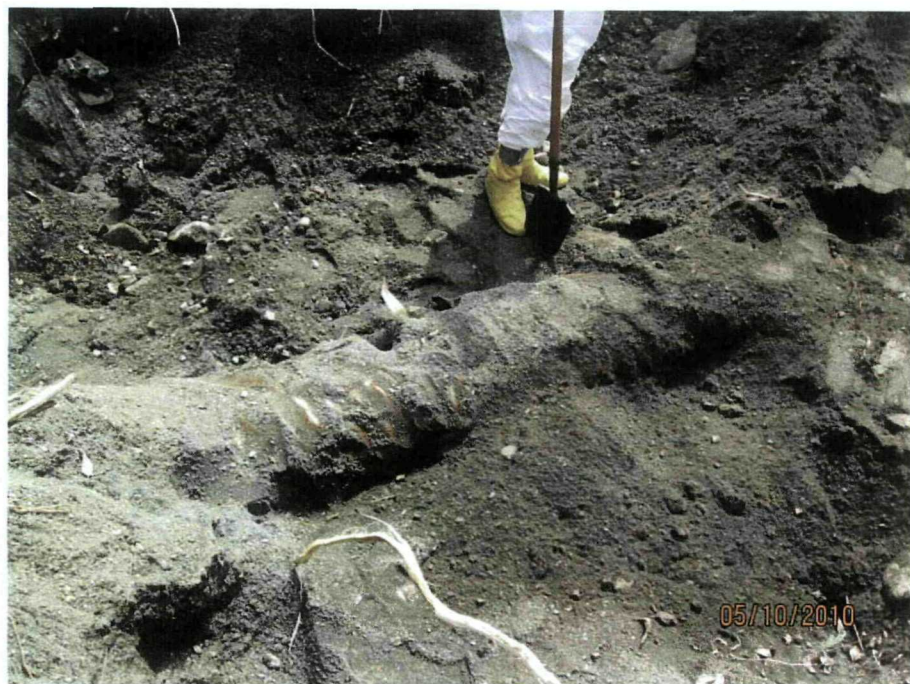
67. Excavation at drain 2

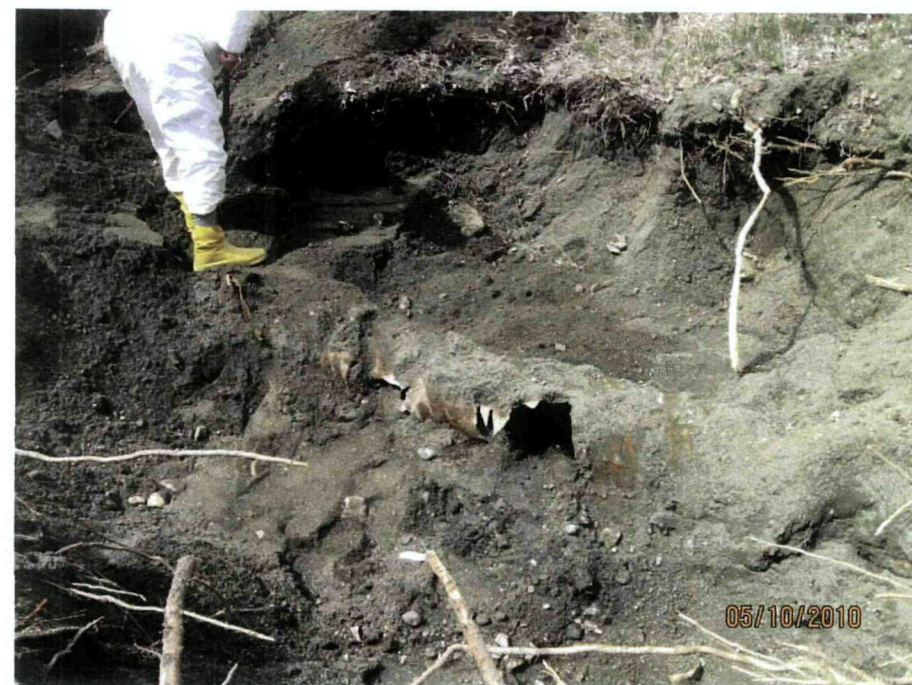
68. Drain 2, 18-inch CMP

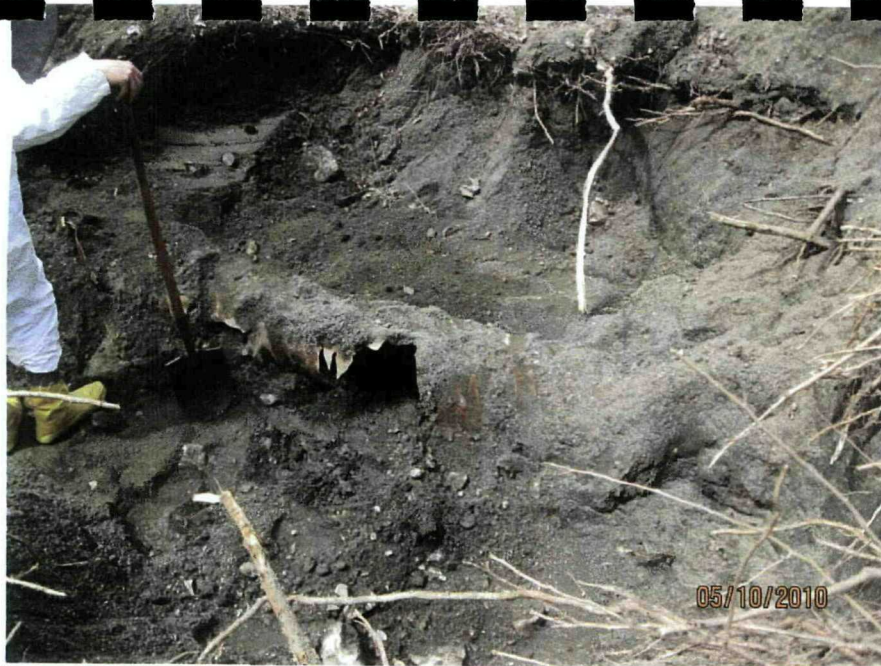
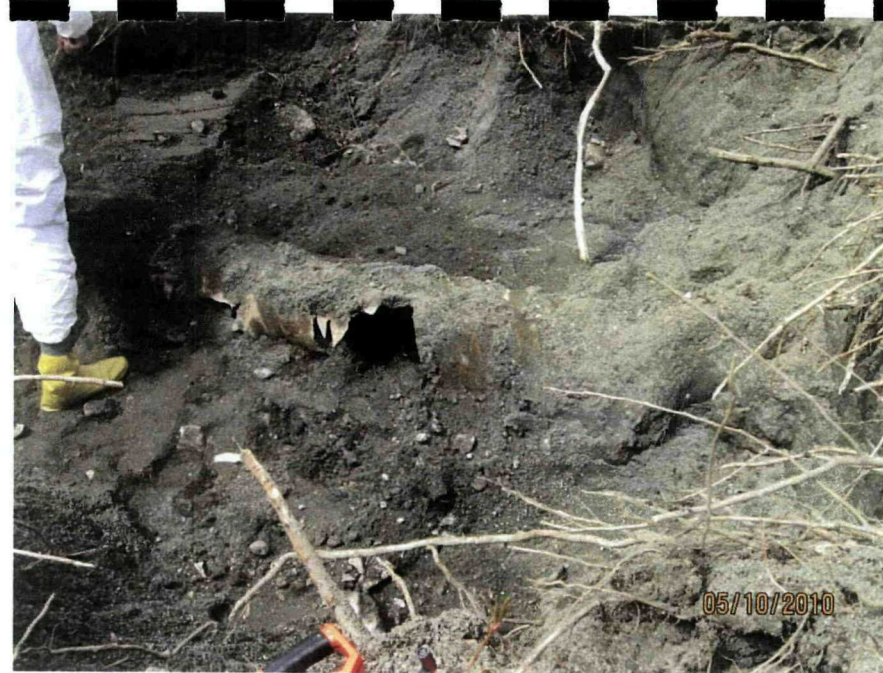
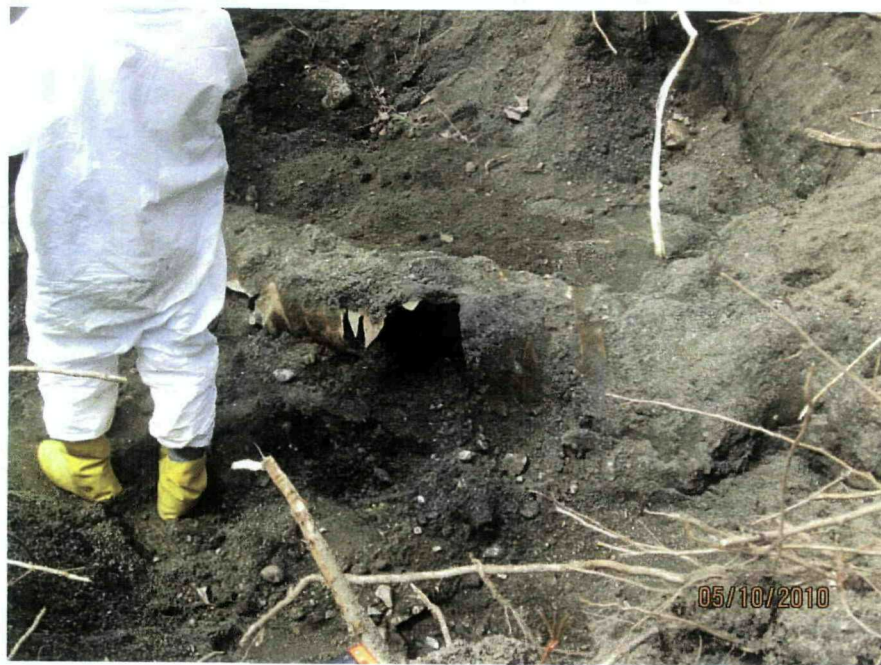
69. Cut in drain 2 from shovel

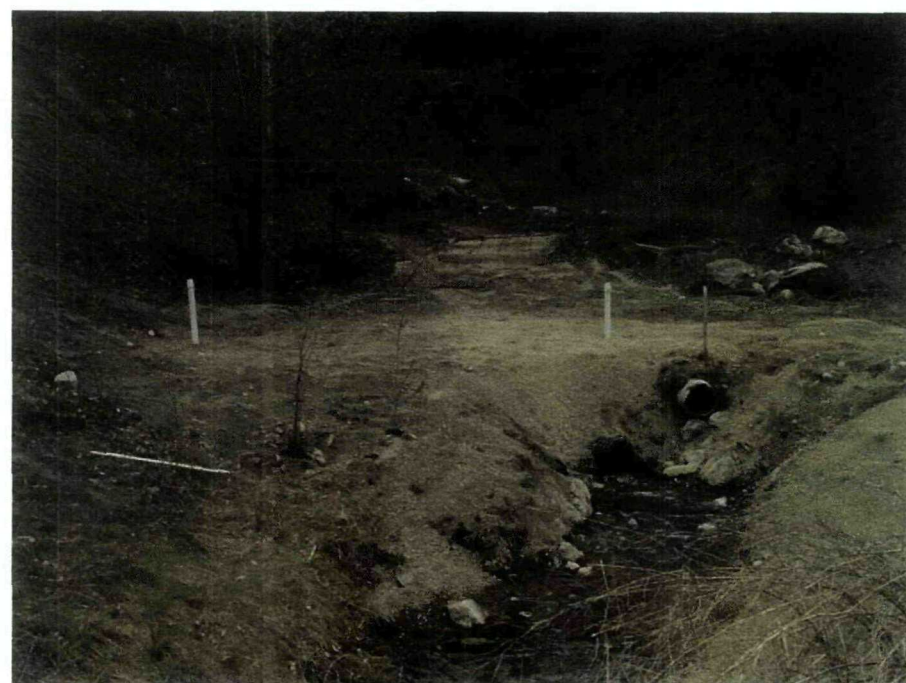
76. New piezometers A9 & A10

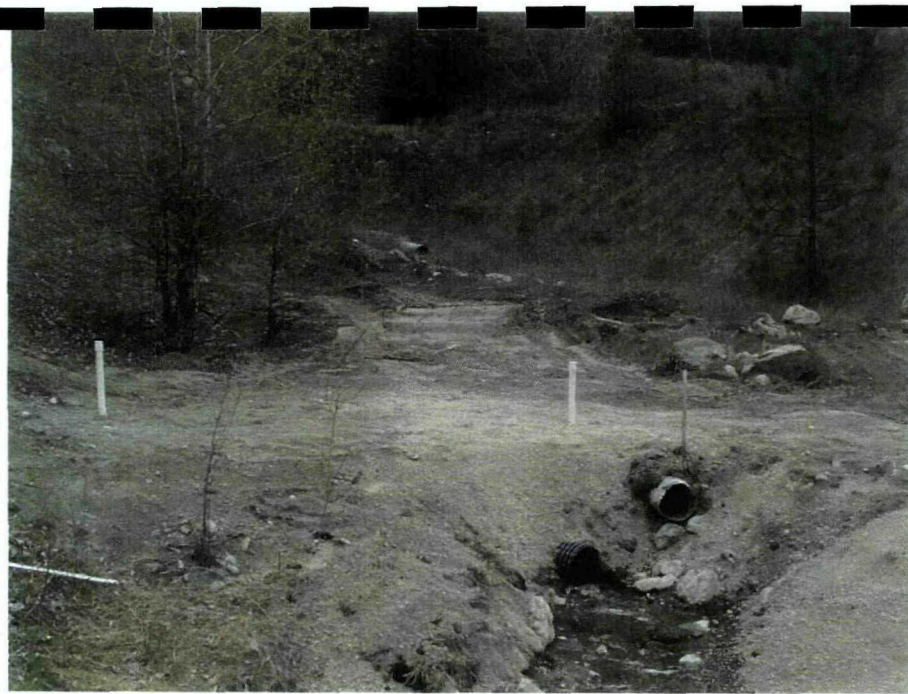
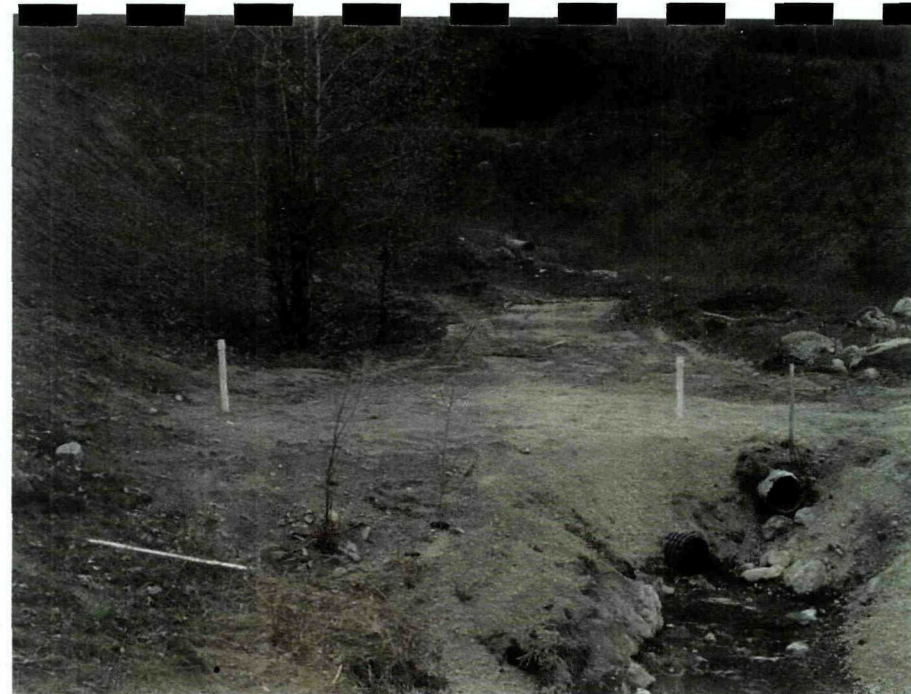
77. A9 & A10 near drain 2 and drain 1

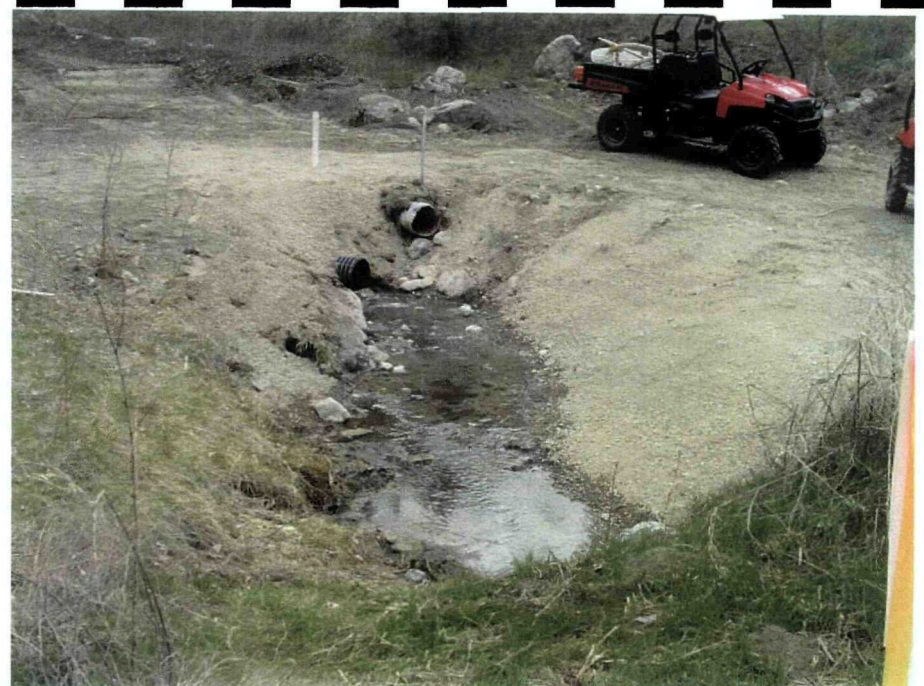
82. Finish grade, drain 3

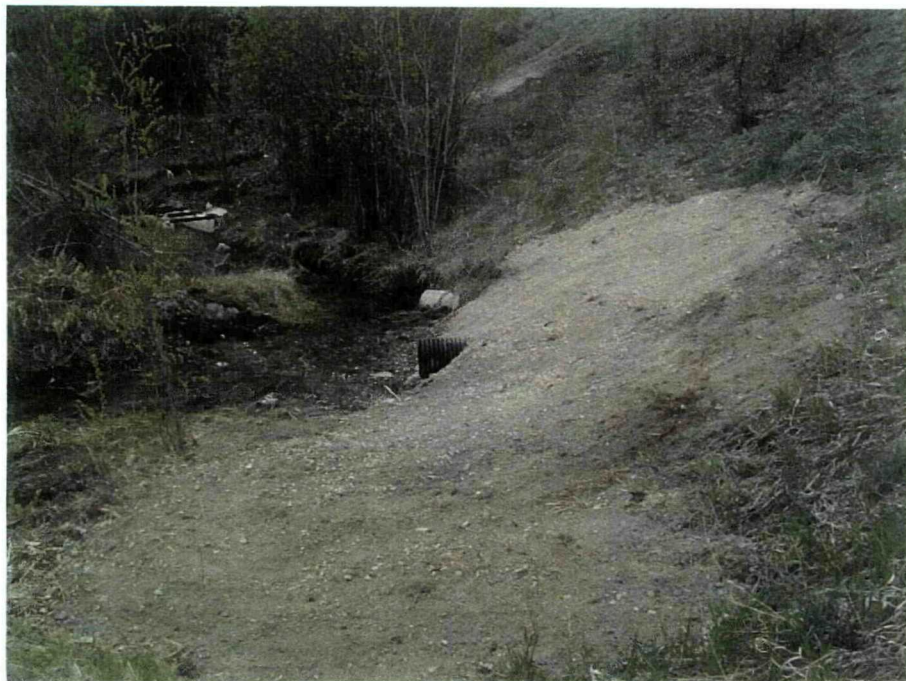
83. Finish grade drain 2 and drain 1

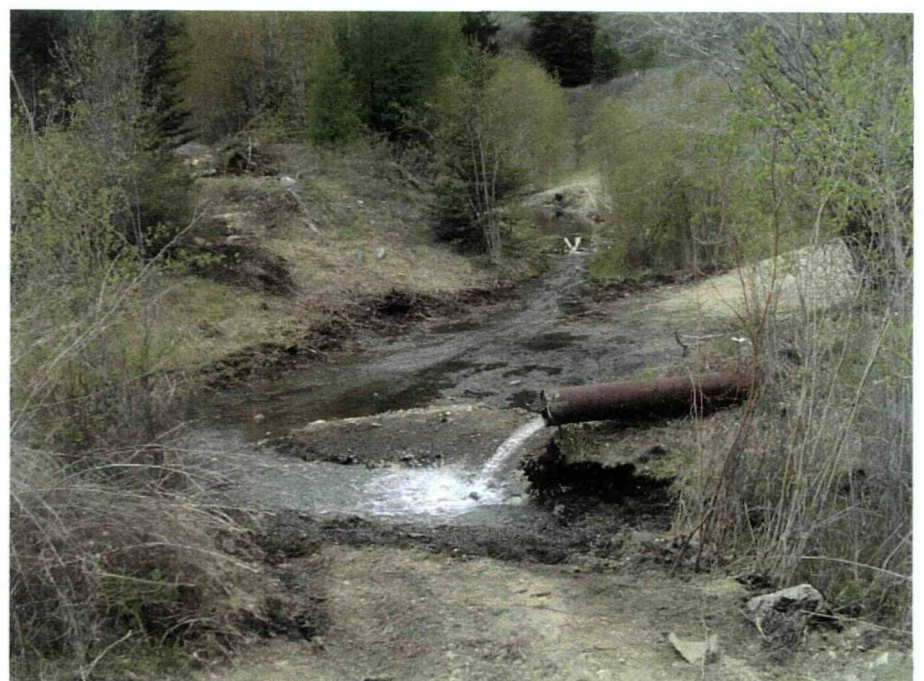
84. Drain 3

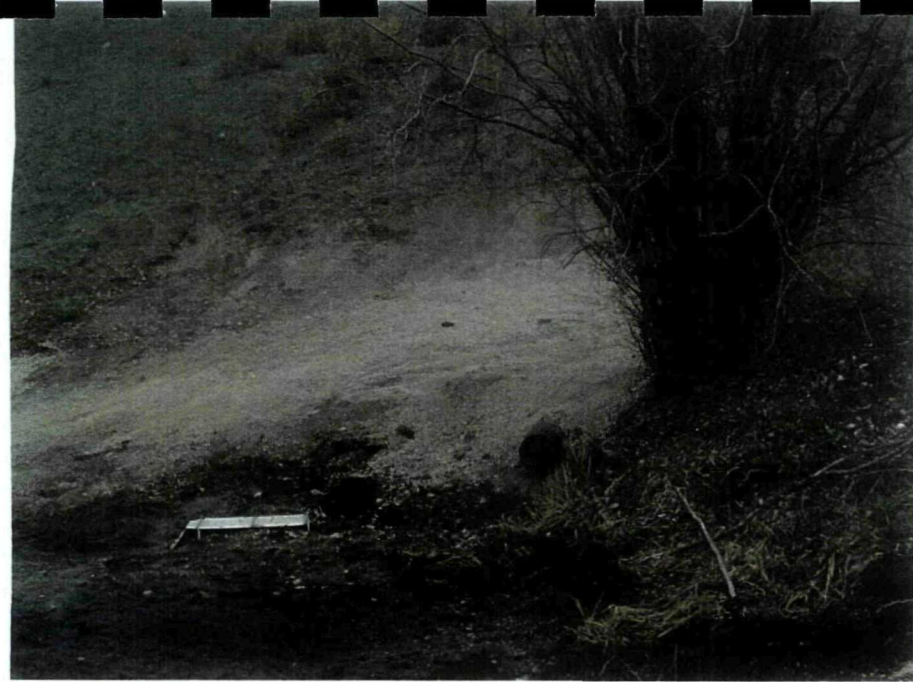
85. Finish grade, drain 6

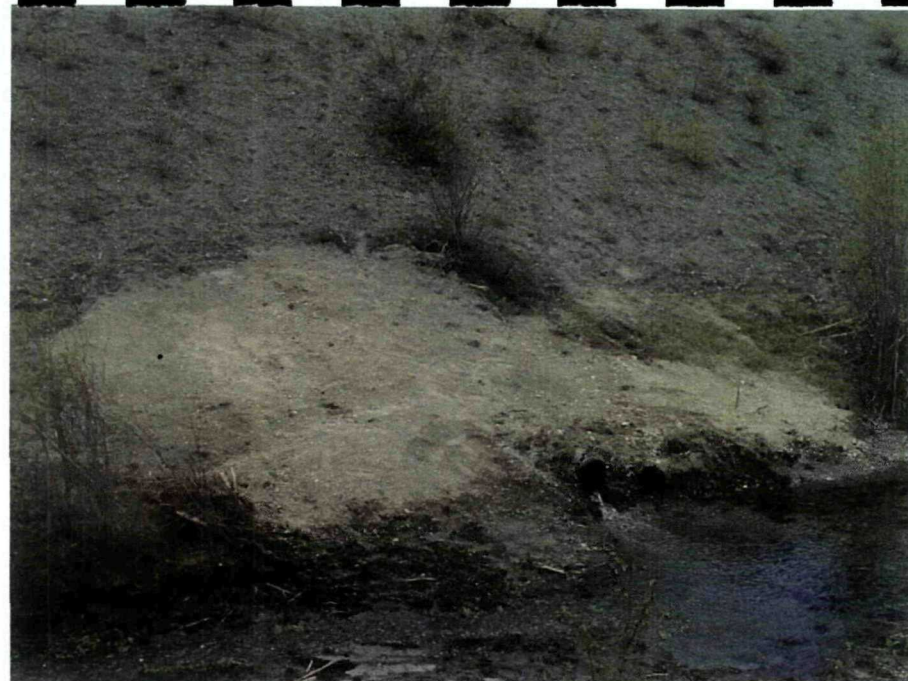
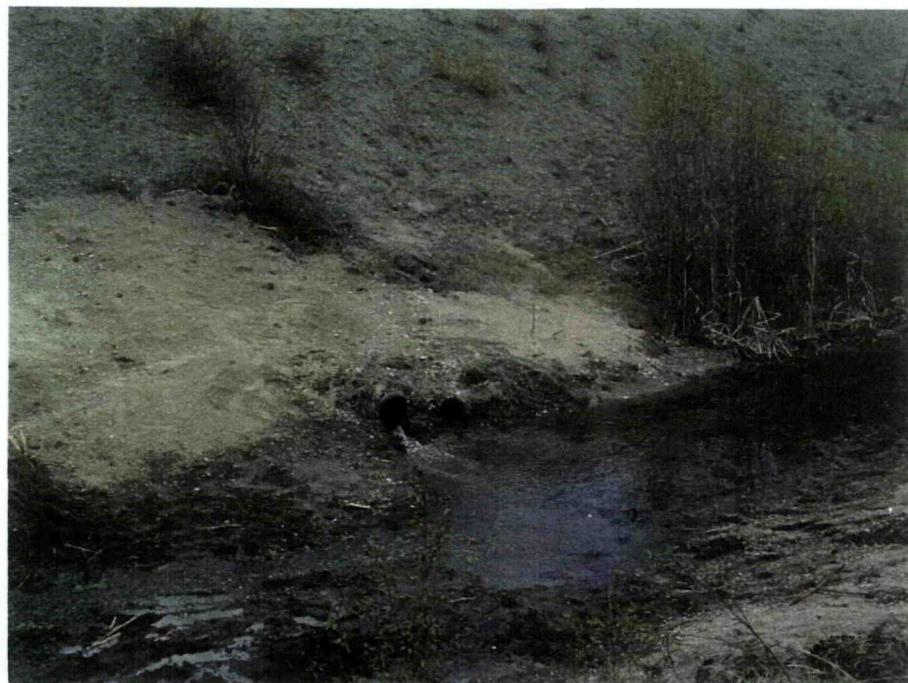
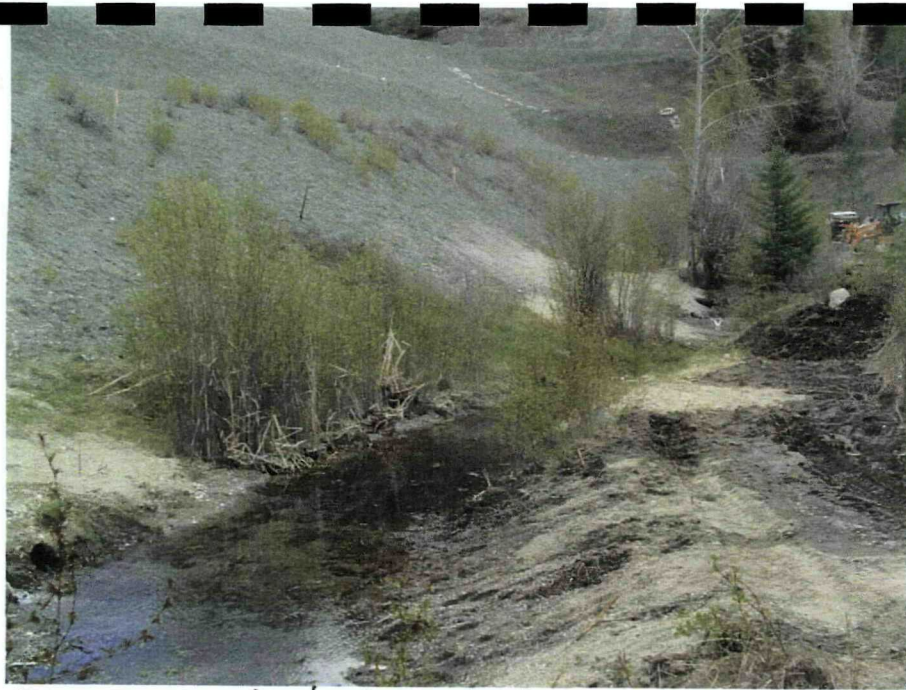
90. Finish grade, drain 11 and drain 10

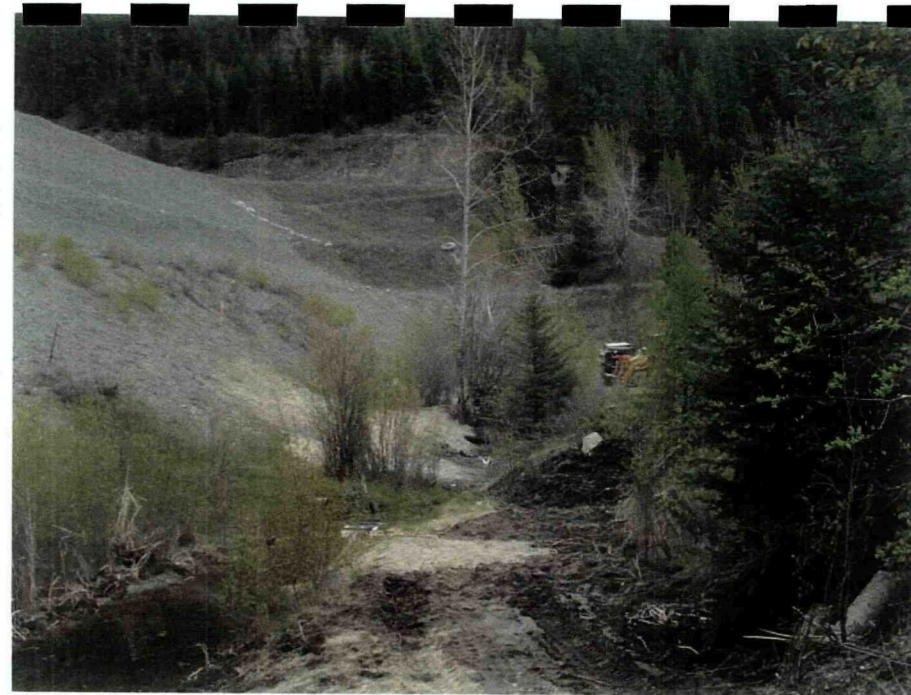
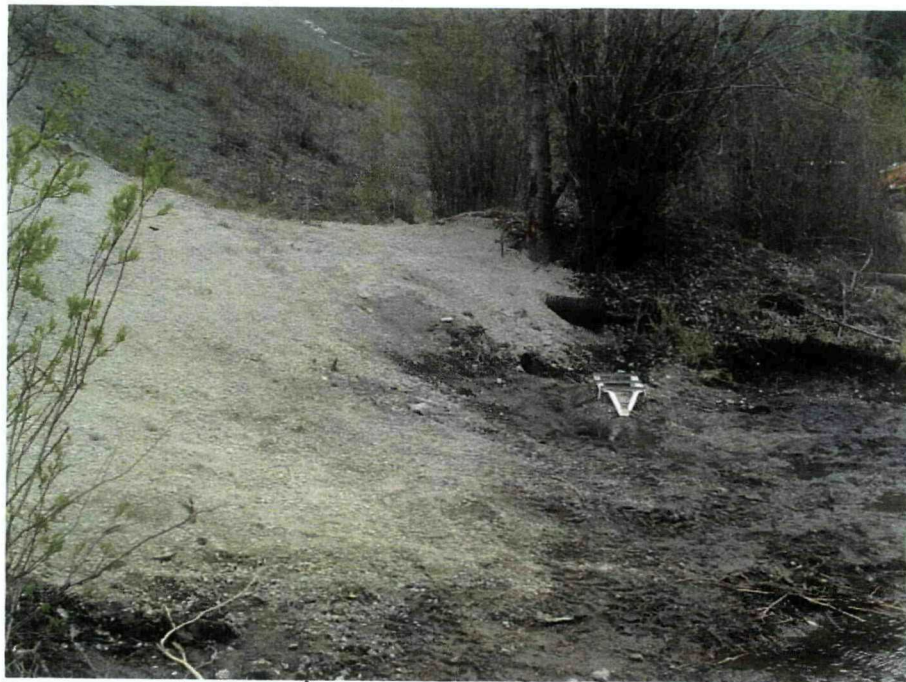
94. Channel below drain 10, cleaned

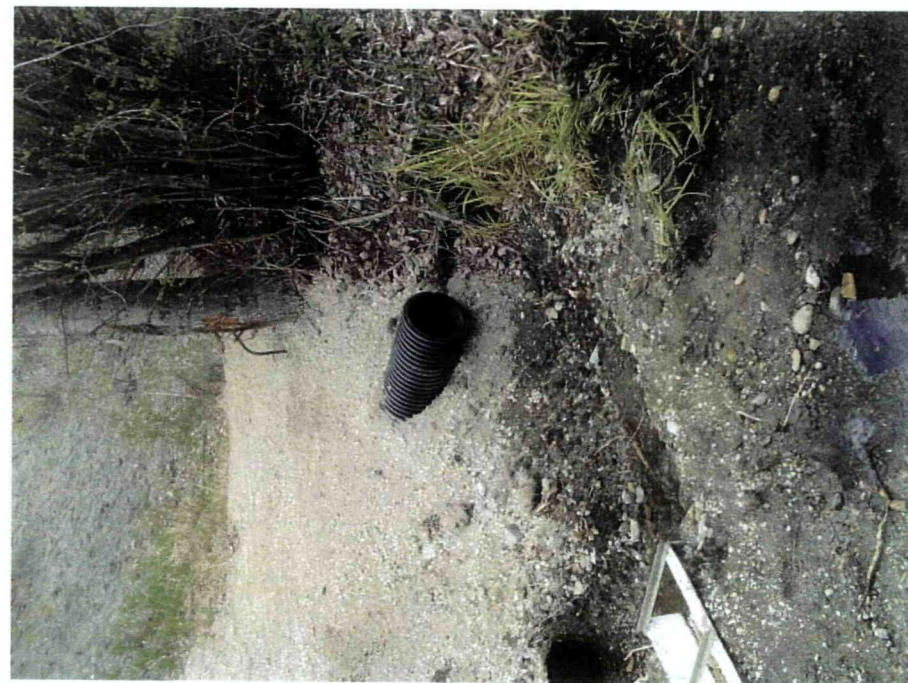
96. Finish grade, drain 8, and drain 7

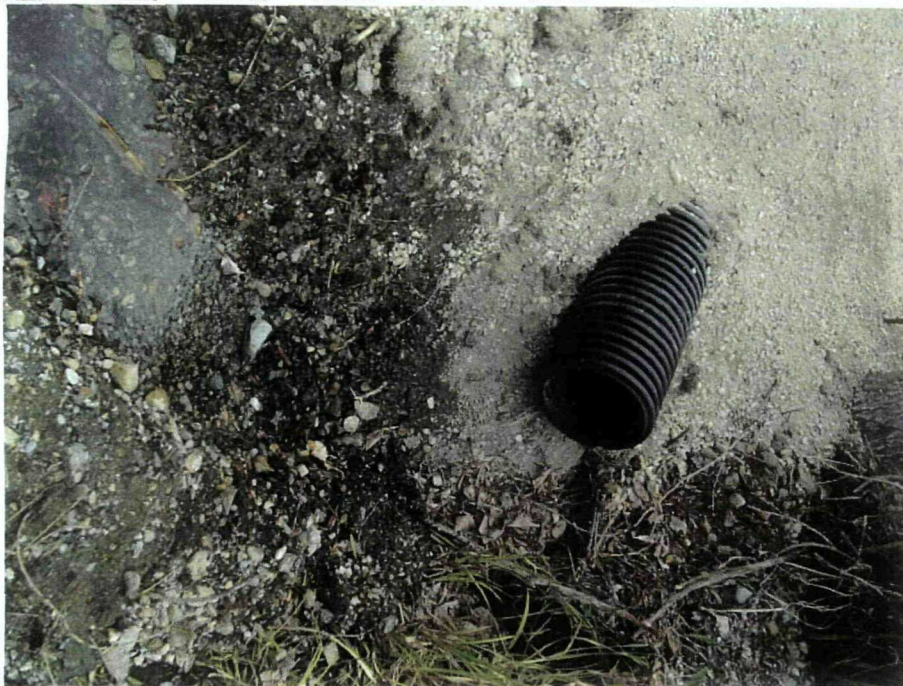
97. Finish grade, drain 7. Note water below drain

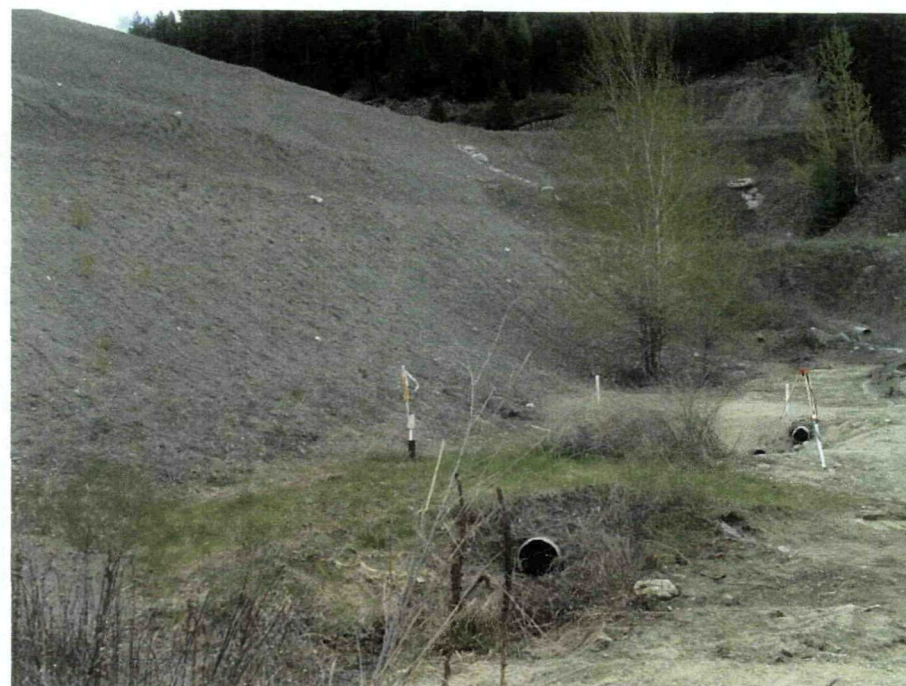
98. Drain 7, new outlet, water below drain

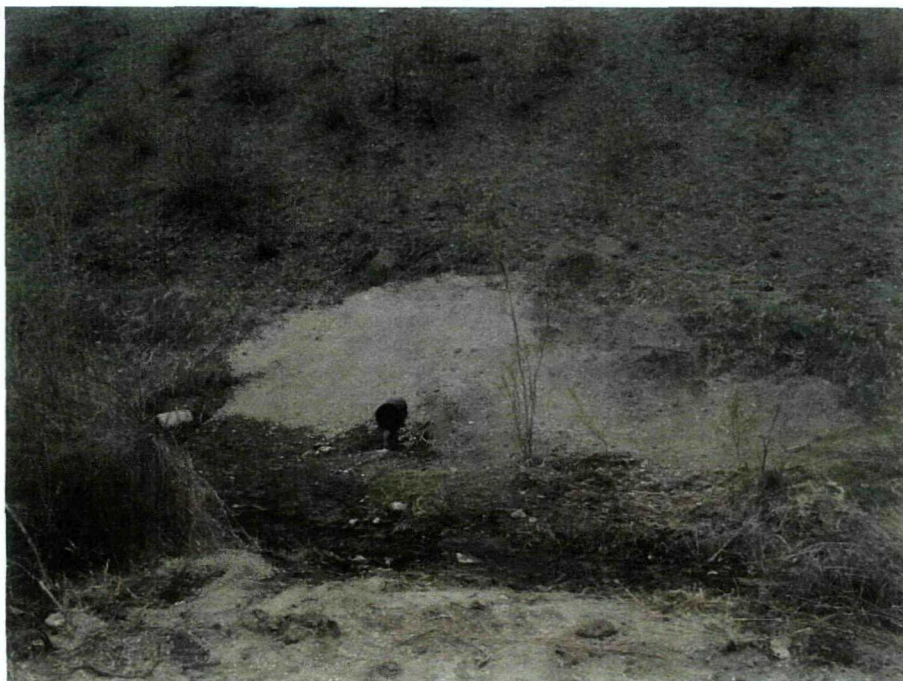
99. Finish grade, drain 2

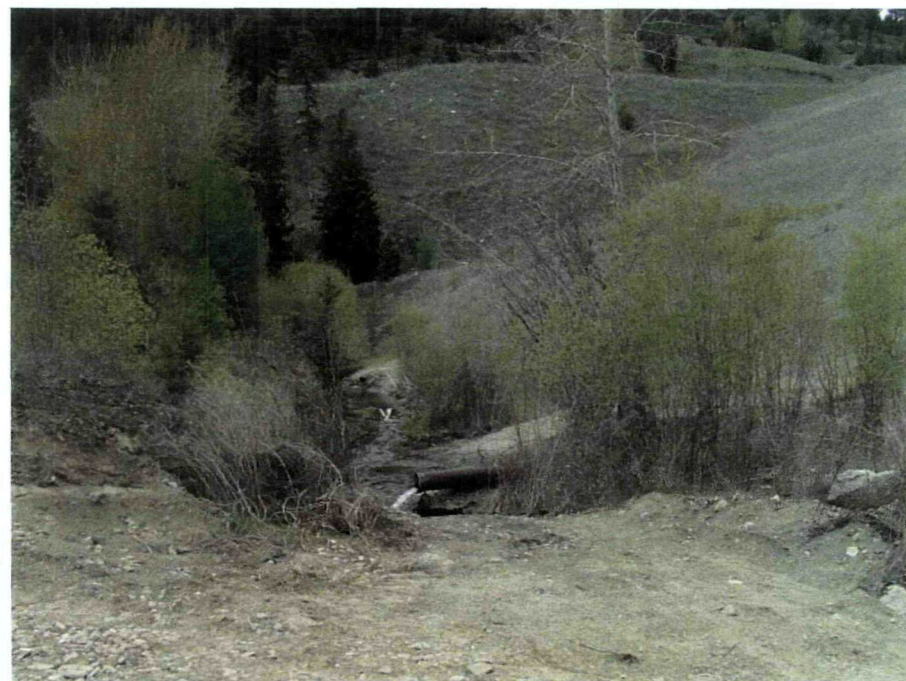
100. Finish grade, drain 3

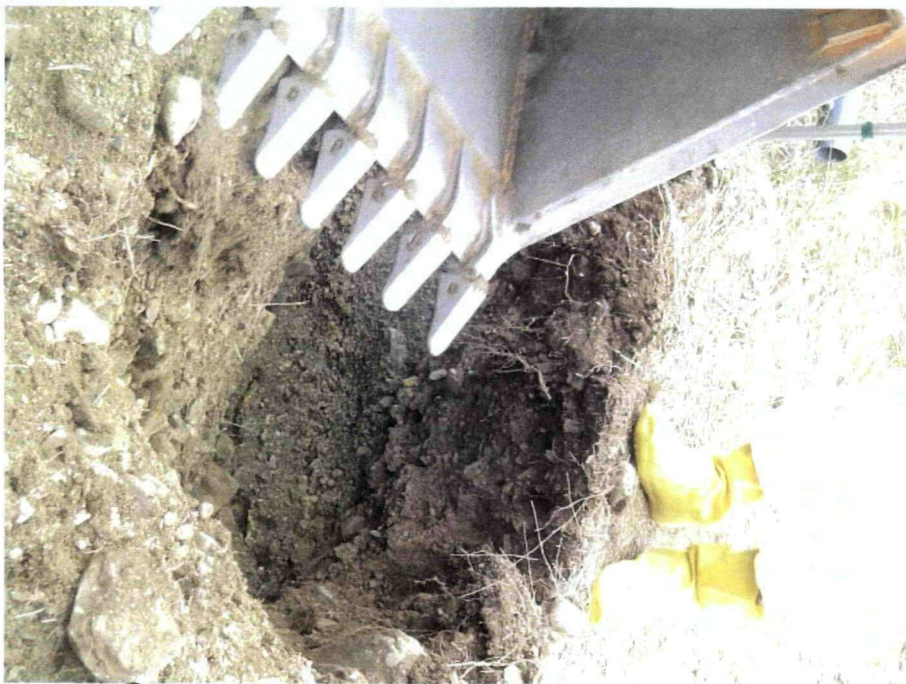
101. Clean up near drain 6

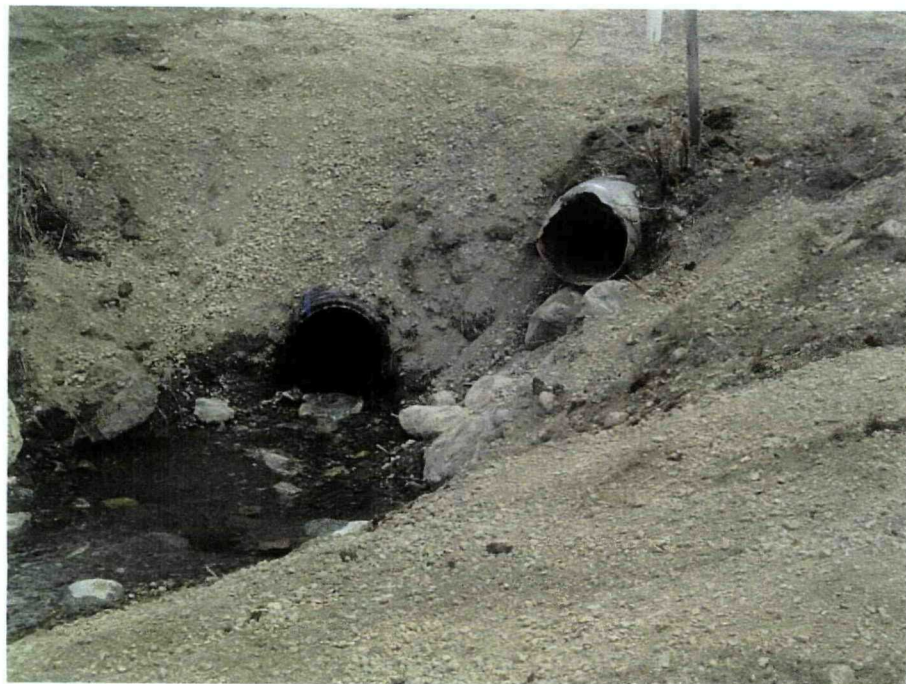
104. Water bearing gravel near A11

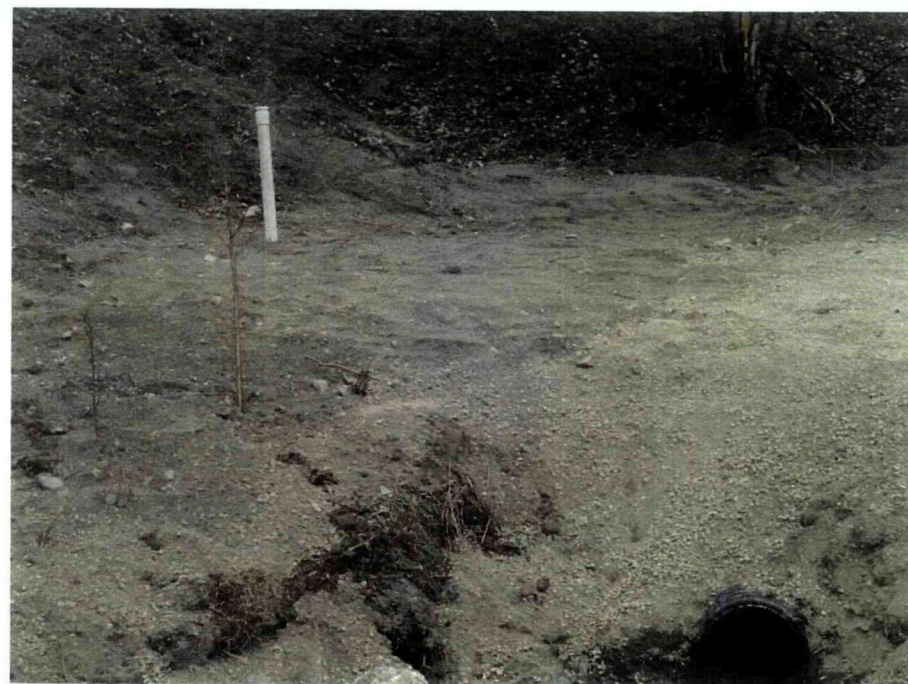
106. Outlet drain 2 and drain 1
